Long Island Sound Eelgrass Management and Restoration Strategy

December 2022

LONG ISLAND SOUND HABITAT RESTORATION INITIATIVE

Submerged
Aquatic
Vegetation

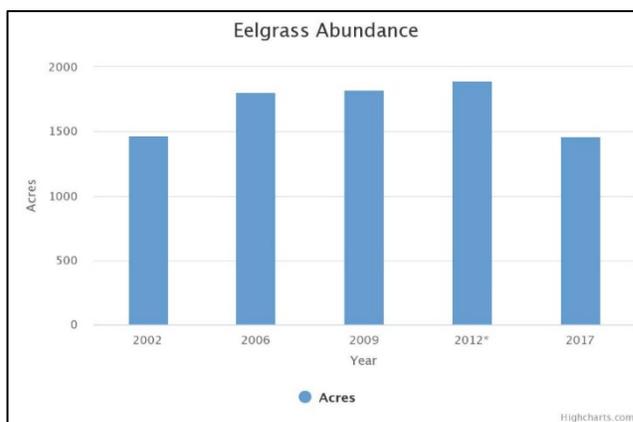
Figure 1 – Eelgrass abundance measured by the USFWS Aerial Surveys (published on LISS Microsite).

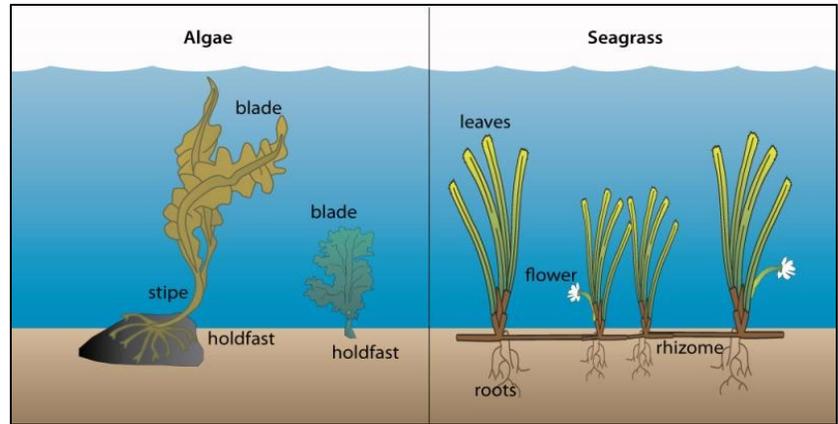
Figure 2 – Differences between algae and seagrass characteristics – showing their extensive roots and rhizome system Source: Reynolds, 2018.

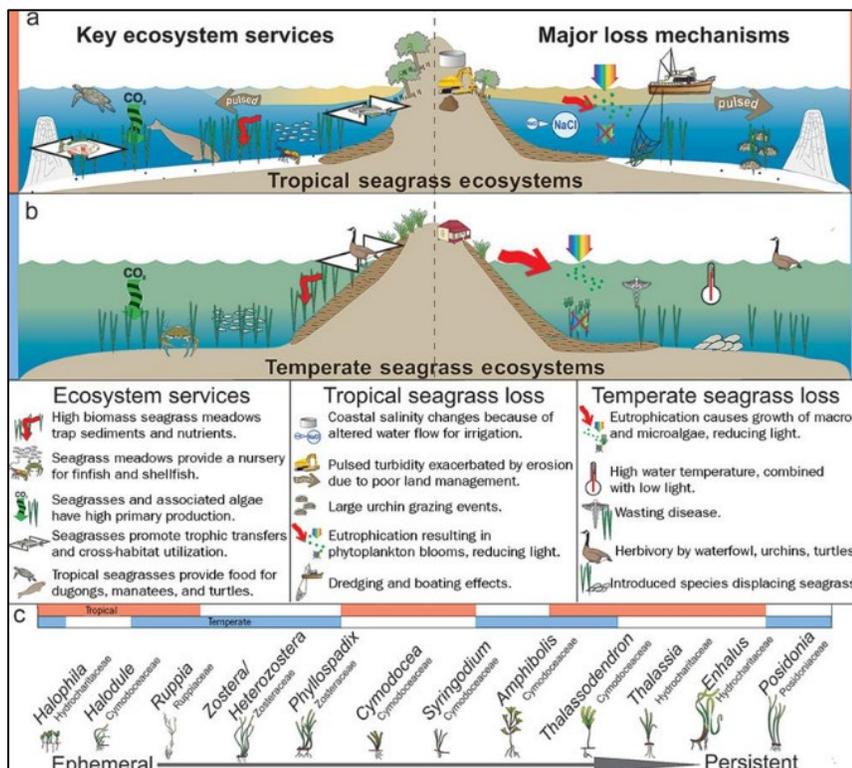
Figure 3 – Conceptual model depicting key ecosystem services and major loss mechanisms in temperate and tropical systems. Source: Orth et al. 2006

Globally, seagrasses provide essential ecosystem services including serving as important nursery habitat, predation refuge, and food source for key recreational and commercial fishery species (Unsworth et al., 2019); stabilizing sediment and reducing wave action therefore increasing shoreline resiliency (Hemminga and Duarte, 2000; Christianen et al., 2013); acting as a sink for nutrients and carbon (i.e., major blue carbon hotspot) (Duarte et al. 2005); and removing excess nitrogen from the water column through denitrification (Zarnoch et al. 2017) – valuing at \$1.9 trillion per year (Costanza et al., 1997; Waycott et al., 2009) (Figure 3 from Orth et al., 2006).

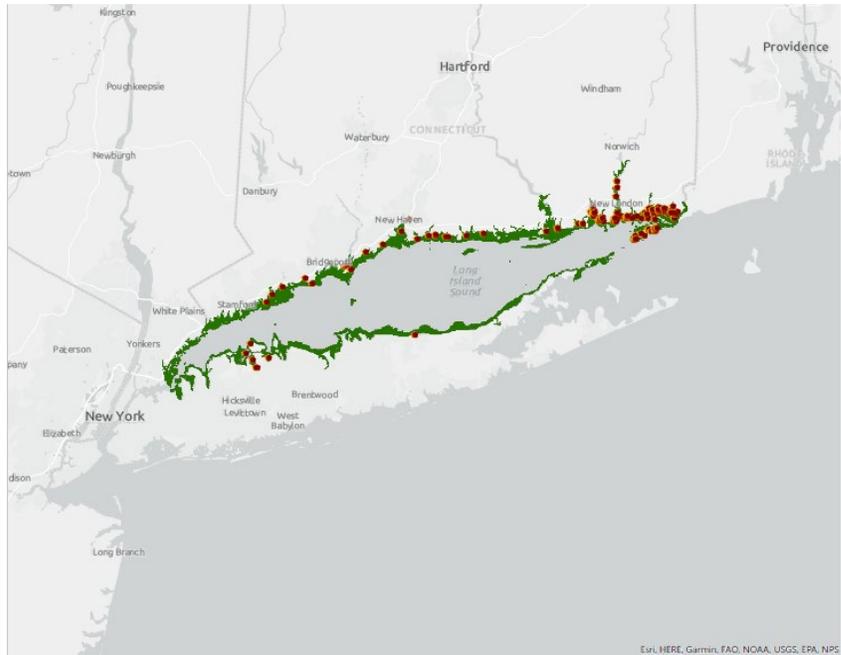
Figure 4 – Map of Long Island Sound showing the historical records and observations of eelgrass meadows (indicated by the red dots); whereas the green layer indicates the probable extent of eelgrass meadows (source: Vaudrey et al., 2013).

Historically, eelgrass was found in embayments from the western to the eastern Sound (Figure 4). The Long Island Sound Habitat Restoration Manual, Chapter 3: Submerged Aquatic Vegetation (2003) defines three time-periods of distinct differences in eelgrass distribution: pre-1931, 1931-2003, and 2003-present. For more detail refer to Appendix A, but to summarize:

- Pre – 1931: Eelgrass in Long Island Sound was abundant and common along the entire coastline. The red dots in Figure 4 depict the historical eelgrass observations in the Sound. Anecdotal observations indicate gaps along the shoreline; however eelgrass was found on both coasts – on the north shore of Long Island the eelgrass was found from Bayville to Orient Point and Fishers Island and on the Connecticut shoreline eelgrass was found from Stamford to Stonington. Developed by the Eelgrass Habitat Suitability Index Model (Vaudrey et al., 2013), the green layer shows the probable extent of eelgrass meadows.

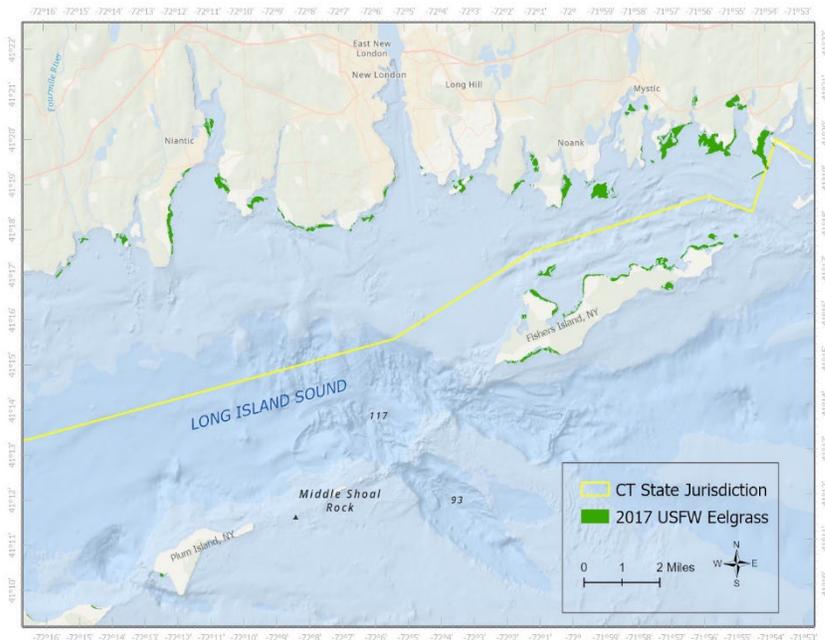
Figure 5 – Map of eastern Long Island Sound showing the eelgrass abundance, in green, mapped by the 2017 USFWS aerial survey (Source: Bradley and Paton, 2018).

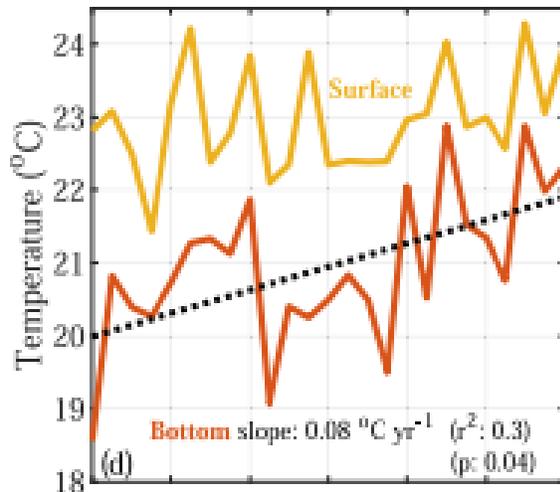
Figure 6 - Connecticut Department of Energy and Environmental Protection's (CT DEEP) Long Island Sound Water Quality Monitoring Program long-term temperature trends in the open Sound. Source: Whitney and Vlahos 2021.

- Temperature: Since the early 1990s, when Connecticut Department of Energy and Environmental Protection (CT DEEP) started the Long Island Sound Water Quality Monitoring Program, increases in both surface and bottom water temperatures have been observed (Figure 6 from Whitney and Vlahos 2021). A 30-year eelgrass dataset from Niantic River Estuary in Connecticut, collected by Millstone Environmental Laboratory at Dominion Energy, shows intense interannual variability (ranging from 4 to 92 hectares) primarily driven by temperature and followed by wind speed and sunlight (Vaudrey, Krumholz, and Calabretta, 2019). Plaisted and colleagues (2022) found that average summer water temperature, collected from eight sites spanning from New Hampshire to Maryland,

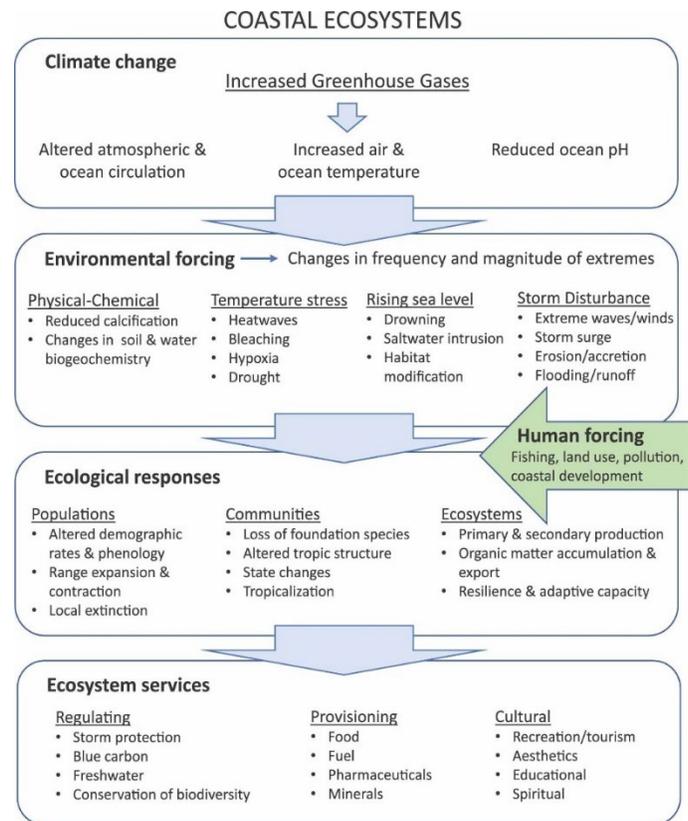
Figure 7 - Conceptual model showing how climate change impacts can scale-up to impact ecosystem services provided by seagrass meadows. Source: Reed et al., 2022

Not only will changing climate conditions impact eelgrass extent and productivity, but it will also severely impact the ecosystem services provided by eelgrass meadows (see Figure 7 from Reed et al., 2022). In addition, it is critical to consider the amplified impacts of multi-stressor interactions on eelgrass meadows. For example, the interaction between impaired water clarity and increased water temperatures are the main driver of eelgrass decline in Chesapeake Bay – particularly in shallow environments (Lefcheck et al., 2017).

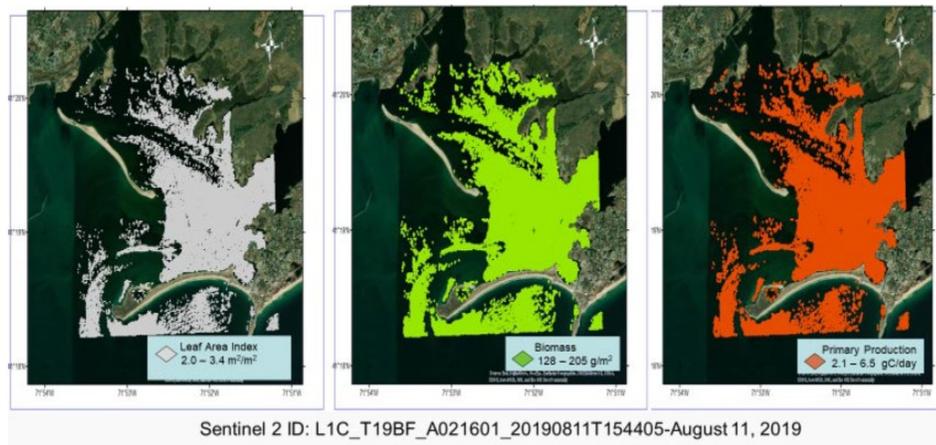
Figure 8 - The distribution of Sentinel 2-based leaf areas index, biomass, and primary productivity in Little Narragansett Bay in 2019

these locations, using satellite imagery, the investigators were able to map leaf area index, biomass, and primary productivity (Figure 8). Please request the report for more information (Keith et al., 2018)

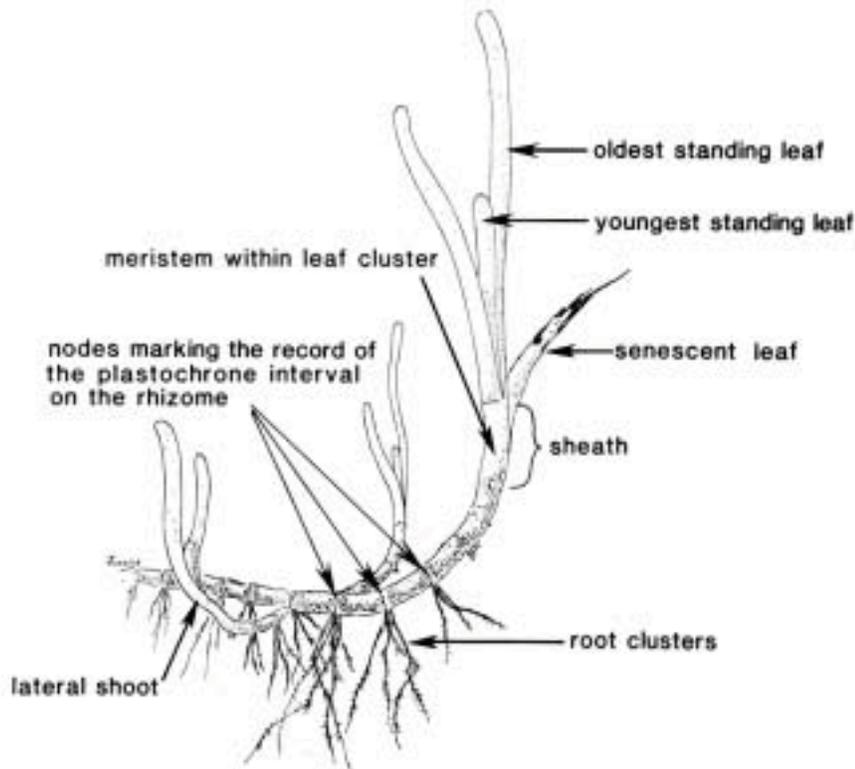
Eelgrass, a kind of seagrass, is the only true marine SAV found in Long Island Sound. Seagrasses are characterized as having linear, grass-like leaves and an extensive root and rhizome system. An eelgrass plant is composed of 3-7 strap-like leaves bound together in a sheath attached to an underground rhizome (Figure 3-1). The rhizome is produced by the basal meristem, which also produces new leaves and lateral shoots. Root clusters from rhizome nodes function as anchors and as the primary sites for nutrient uptake. The base of the lateral shoot pushes through the sediment as the plant grows

FIGURE 3-1. Major Features of the Morphology of *Zostera Marina*
(From Thayer and Fonseca, 1984)

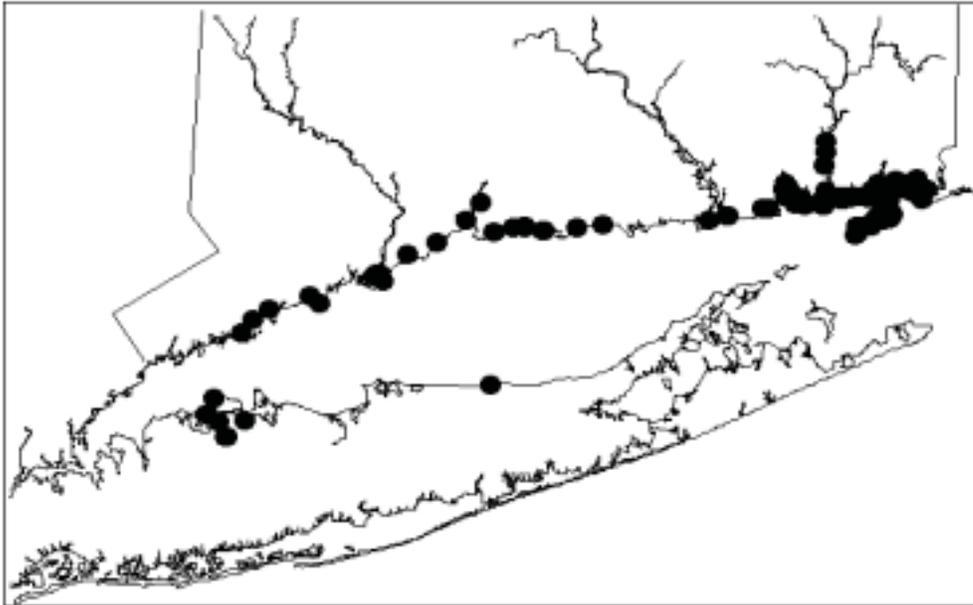
FIGURE 3.2. Historical Eelgrass Distribution

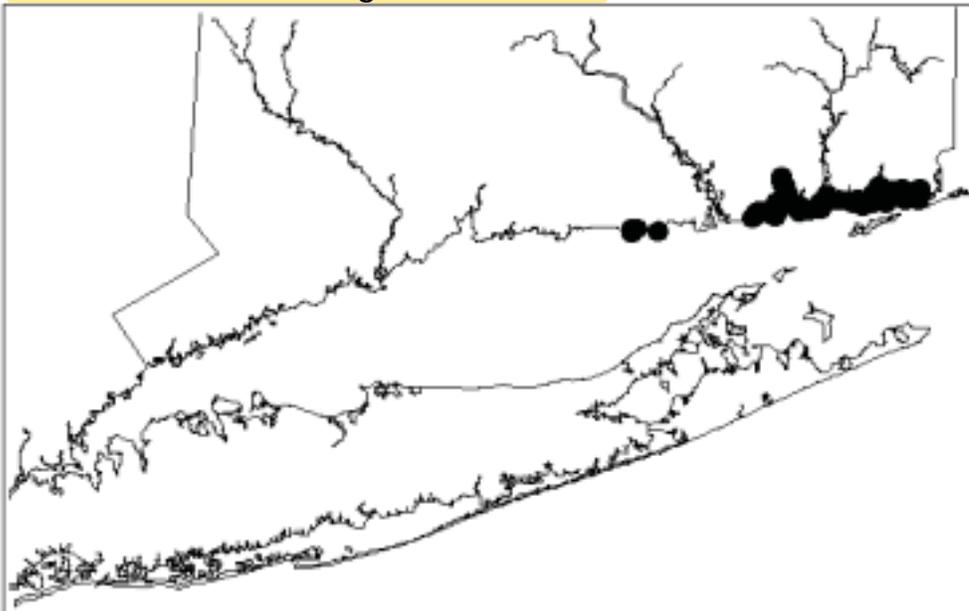
FIGURE 3.3. Current Eelgrass Distribution

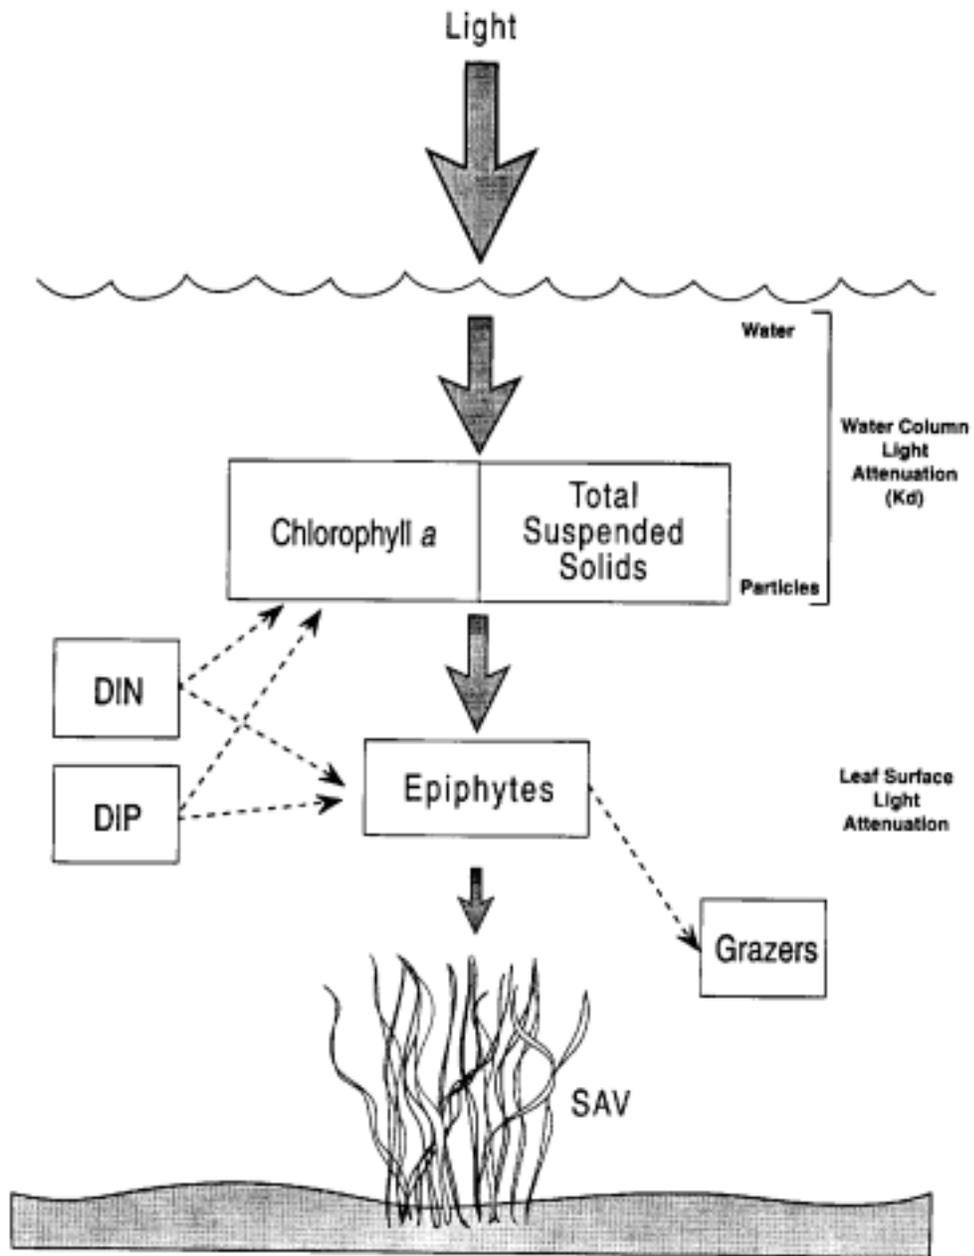
FIGURE 3-4. Conceptual Model of SAV/Habitat Interactions

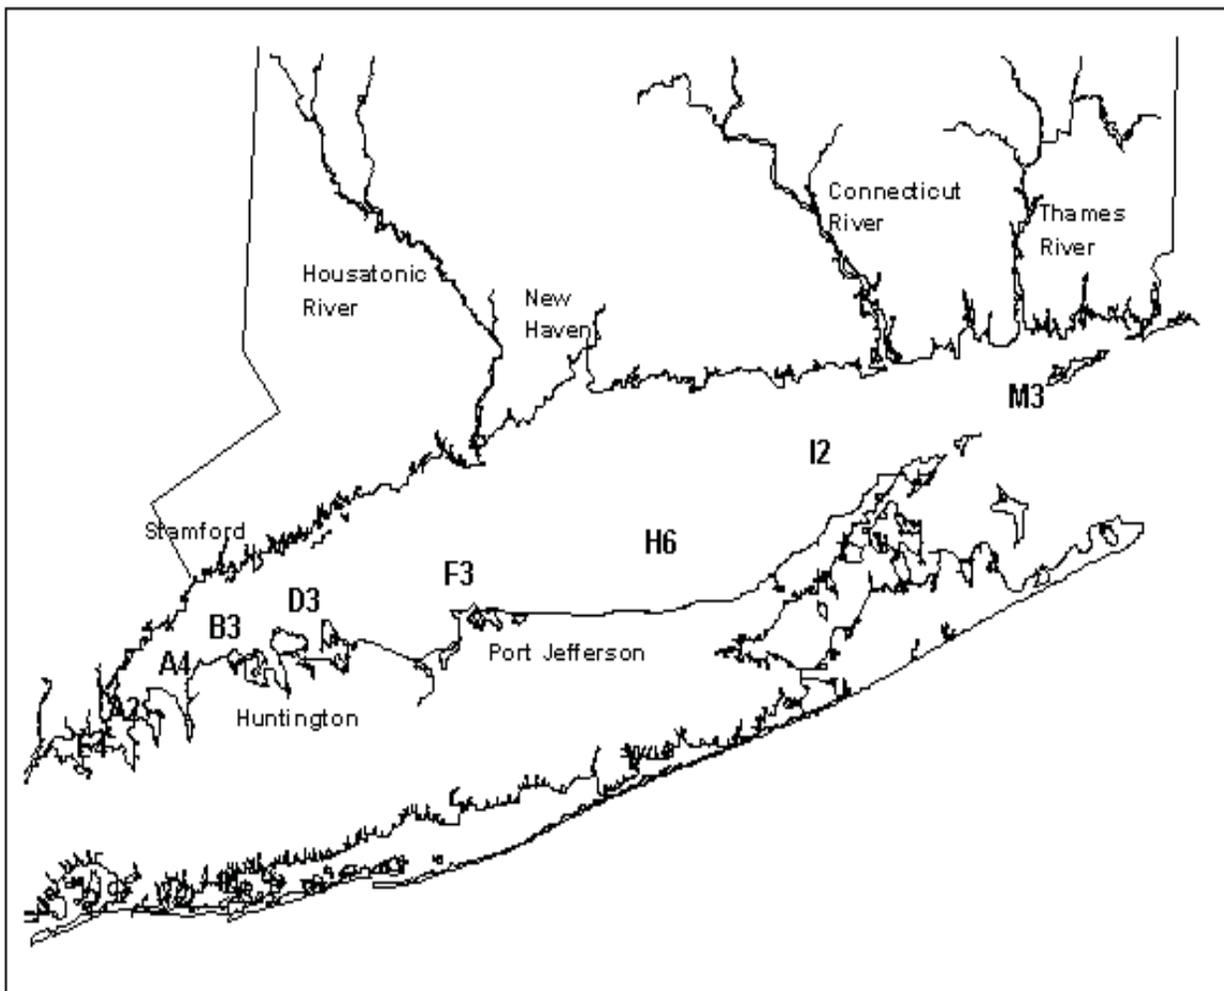
FIGURE 3-5. Long Island Sound Offshore Water Quality Sampling Locations. Data from CTDEP and NYCDEP monitoring programs.

Monitoring stations in the Sound (Figure 3-5) indicate that the maximum allowable level of several water quality parameters for eelgrass are being exceeded: dissolved inorganic nitrogen (DIN), dissolved inorganic phosphorous (DIP), and chlorophyll a (CHLA). Five years (1992, 1994, 1996, 1998, and 2000) of offshore data are presented in Appendix 3. In general, the graphs show impaired water quality following an east to west trend with the least favorable eelgrass conditions occurring in western LIS. For each parameter, a horizontal line represents the maximum acceptable level for eelgrass growth.

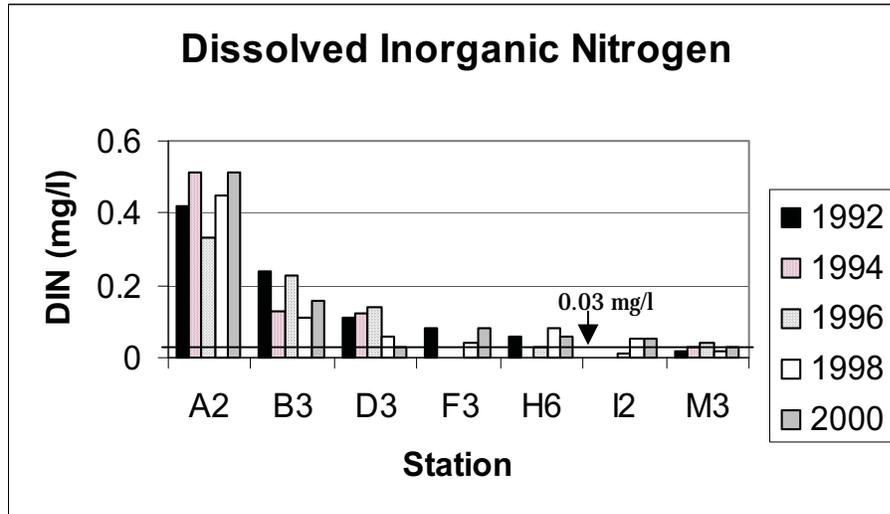
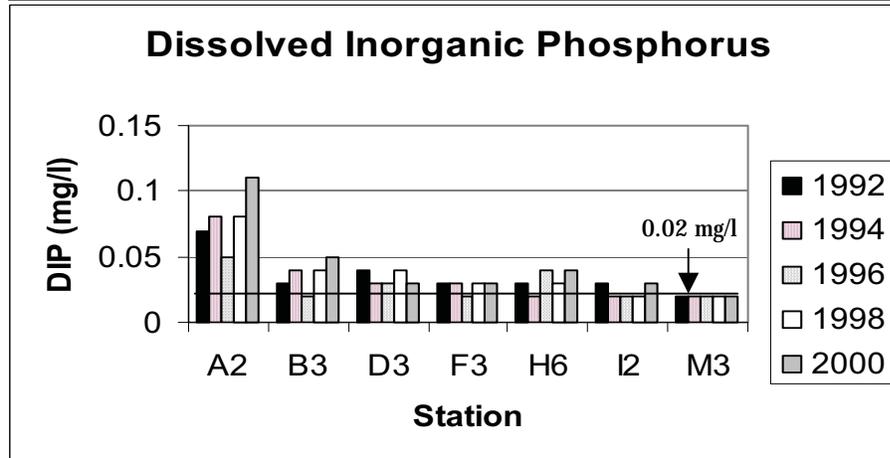
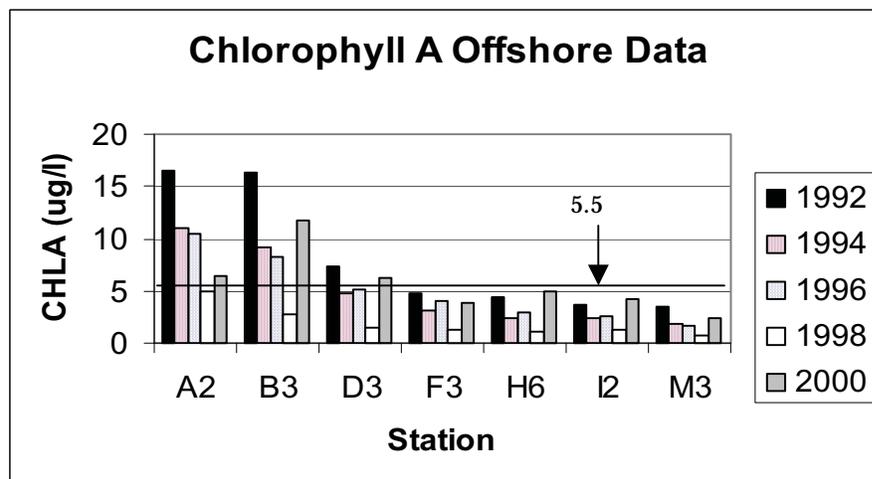
GRAPHS OF WATER QUALITY DATA FOR FIVE OFFSHORE SAMPLING STATIONS
